Manhole Inspection Summary

Manhole # S15C1_031MH

Inspection ☐ Is Incomplete Rating: **4) Poor**

Location Address: **1701 INVERNESS AV**

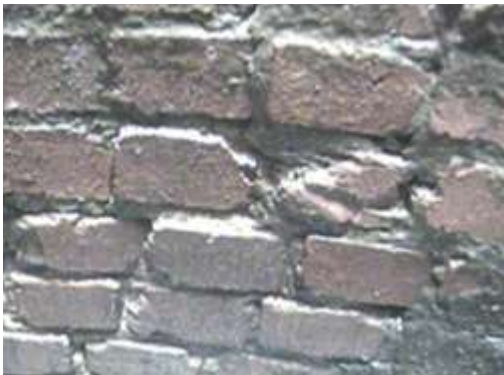
Defect 5

Condition: ☐ Sound ☐ Cracked ☒ **Root Intrusion** ☐ Loose Brick ☒ **Deteriorated**

DETERIORATED BARREL BRICKS AND MORTAR

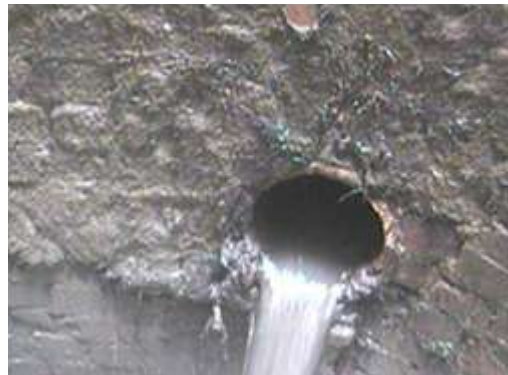
Defect 6

Infiltration: ☐ None ☐ Joint ☐ Cracks ☐ Mortar ☒ **Roots** ☐ Wall

ROOT INTRUSION @ BARREL

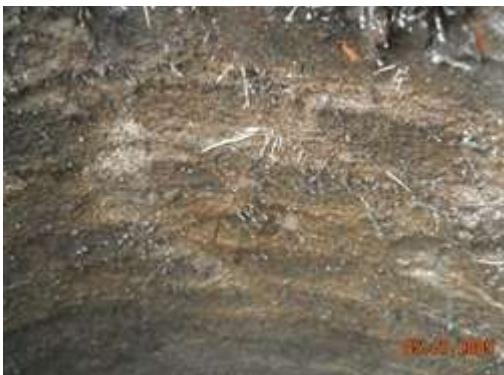
Defect 4

Condition: ☐ Sound ☐ Cracked ☒ **Root Intrusion** ☐ Loose Brick ☐ Deteriorated

CORBEL ROOT INTRUSION

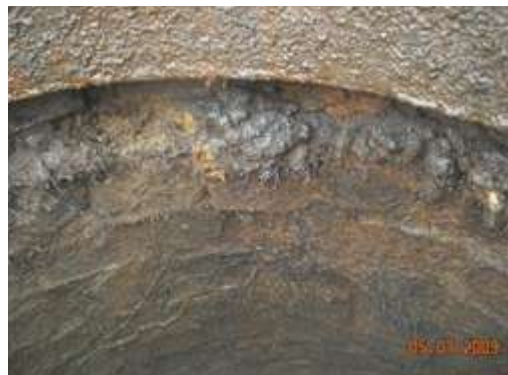
Defect 3

Infiltration: ☐ None ☒ **Joint** ☐ Cracks ☐ Mortar ☒ **Roots** ☐ Wall

ROOT INTRUSION @ CHIMNEY,
CHIMNEY INFILTRATION AT JOINT

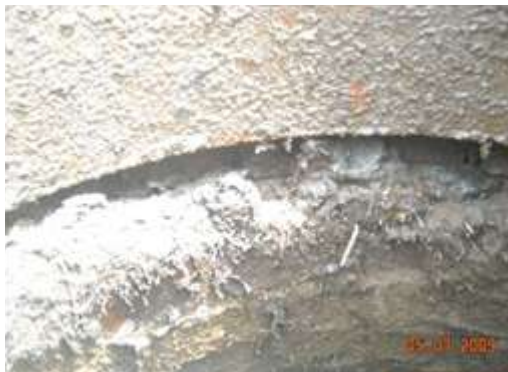
Defect 2

Condition: ☐ Sound ☐ Cracked ☒ **Root Intrusion** ☐ Loose Brick ☒ **Deteriorated**

DETERIORATED CHIMNEY

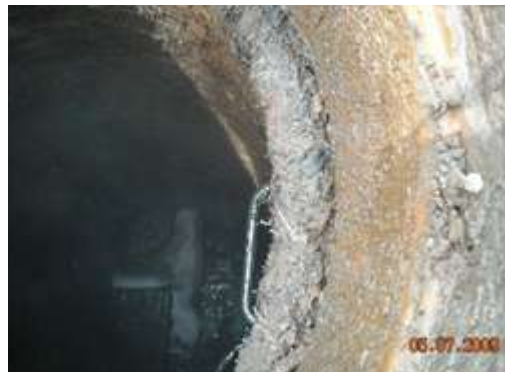
Defect 1

Offset: **2** (in.)

FRAME OFFSET

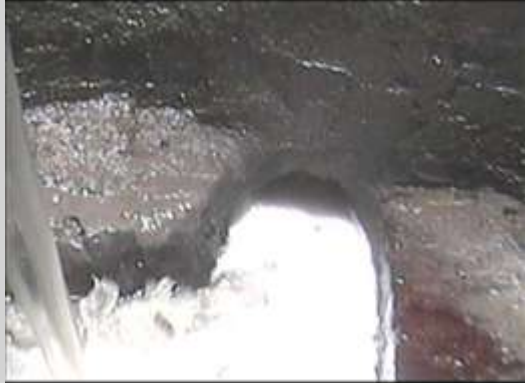
12 O'Clock Outflow

Pipe Height: **8.4** (in.) Rod and Bar (Angled)
Pipe Material: **Clay** ☐ Pipe Lined
Invert Depth: **12.97** (ft.) Flow Characteristics: **Fast**
Deposits: ☒ None ☐ Mud ☐ Sludge ☐ Debris ☐ Grease
Silt Depth: **0** (in.) Deposits Extent:
Infiltration: **None** Pipe Seal Cond: **Cracked**

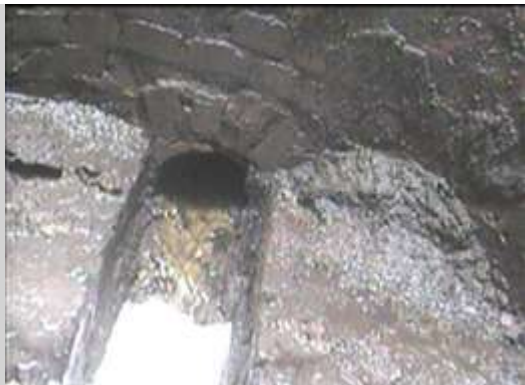
6 O'Clock Inflow

Pipe Height: **8.4** (in.) Rod and Bar (Angled)
Pipe Material: **Clay** ☐ Pipe Lined
Invert Depth: **12.70** (ft.) Flow Characteristics: **Slow**
Deposits: ☐ None ☒ **Mud** ☐ Sludge ☒ **Debris** ☐ Grease
Silt Depth: **2.5** (in.) Deposits Extent: **Medium**
Infiltration: **None** Pipe Seal Cond: **Cracked**

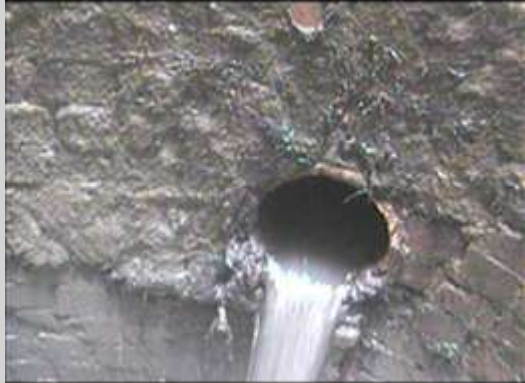
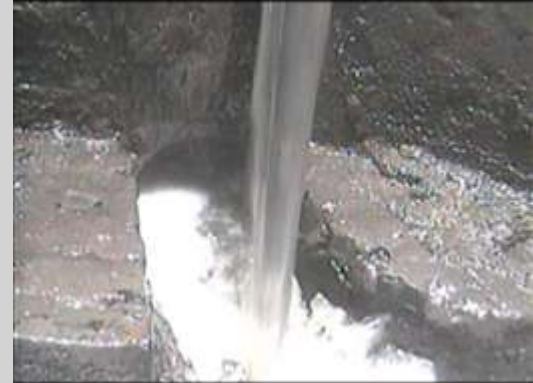
9 O'Clock Inflow

Infiltration: **None** Pipe Seal Cond: **Roots**

Drop Condition: **Clogged**
